Manhole Inspection Summary

Manhole # S69M__010MH

Insp Date: 1/30/08 9:13 AM

Location Address: **6707 German Hill Rd.**

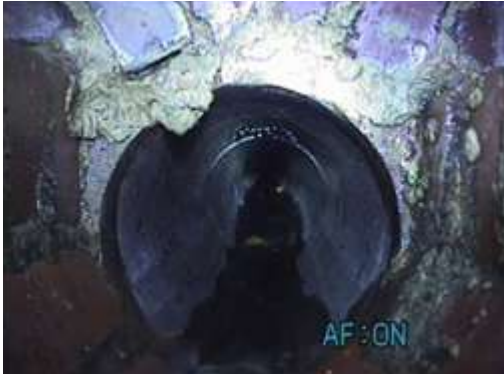
Defect 1

crack in pipe seal, crack in mortar, 11:00
outgoing 12 o'clock

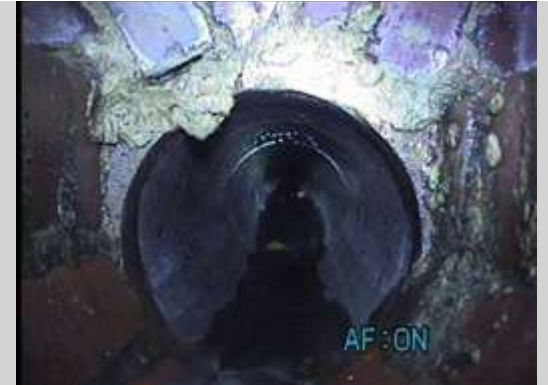
12 O'Clock Outflow

8 in. Circular Gravity Sewer
Pipe Out @ 12 O'Clock

Pipe Height: **8.4** (in.) Rod and Bar (Angled)
Pipe Material: **Clay** ☐ Pipe Lined
Invert Depth: **8.75** (ft.) Flow Characteristics: **Slow**
Deposits: ☒ None ☐ Mud ☐ Sludge ☐ Debris ☐ Grease
Silt Depth: (in.) Deposits Extent:
Infiltration: **None** Pipe Seal Cond: **Cracked**

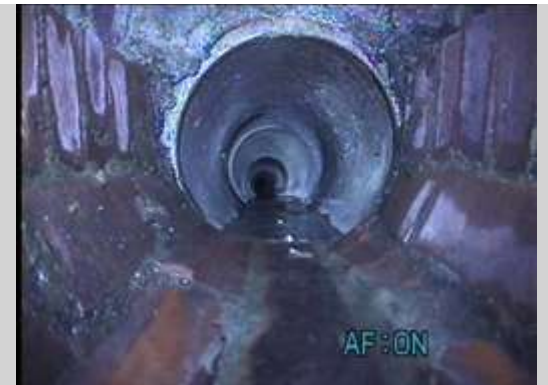
6 O'Clock Inflow

8 in. Circular Gravity Sewer
Pipe In @ 6 O'Clock

Pipe Height: **8.4** (in.) Rod and Bar (Angled)
Pipe Material: **Clay** ☐ Pipe Lined
Invert Depth: **8.38** (ft.) Flow Characteristics: **Slow**
Deposits: ☒ None ☐ Mud ☐ Sludge ☐ Debris ☐ Grease
Silt Depth: (in.) Deposits Extent:
Infiltration: **None** Pipe Seal Cond: **Sound**
